MPERG Report 2006-1

Bioengineering Trials at Noname Creek Post-Fire Evaluation

Stu Withers

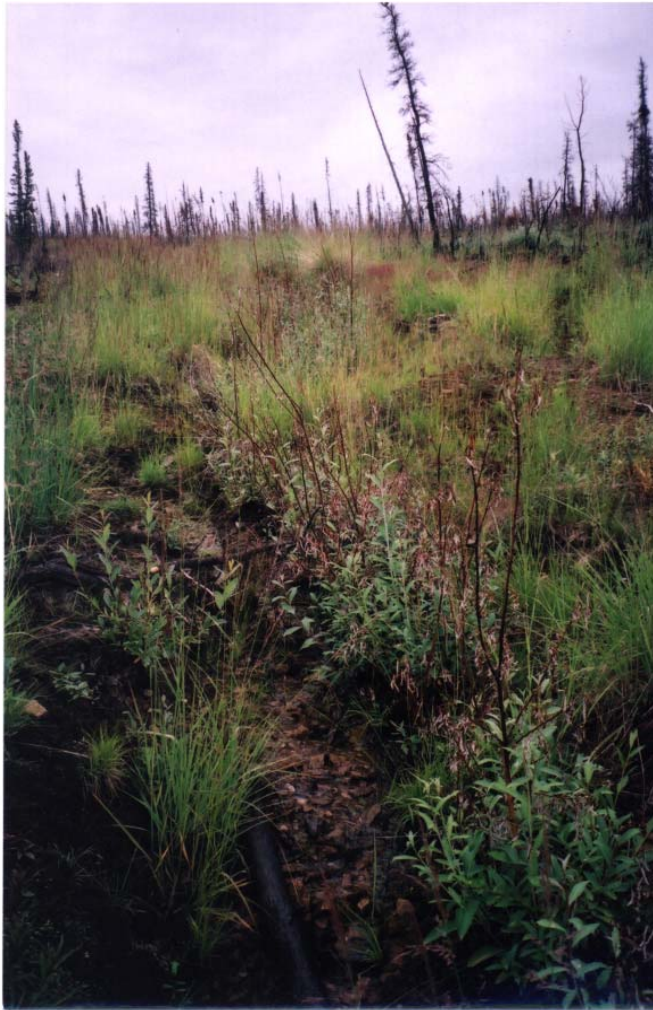
The upper pole drain (upstream from Gully Break #1) has survived the fire and is sprouting well. Most of the willow cuttings that were staked beside and upstream from the pole drain were burned, but are resprouting near ground level. Some water is flowing through the drain; water is also flowing beside the drain in places, although very little new erosion has occurred.

Upper pole drain – note willows are scorched on top but resprouting below

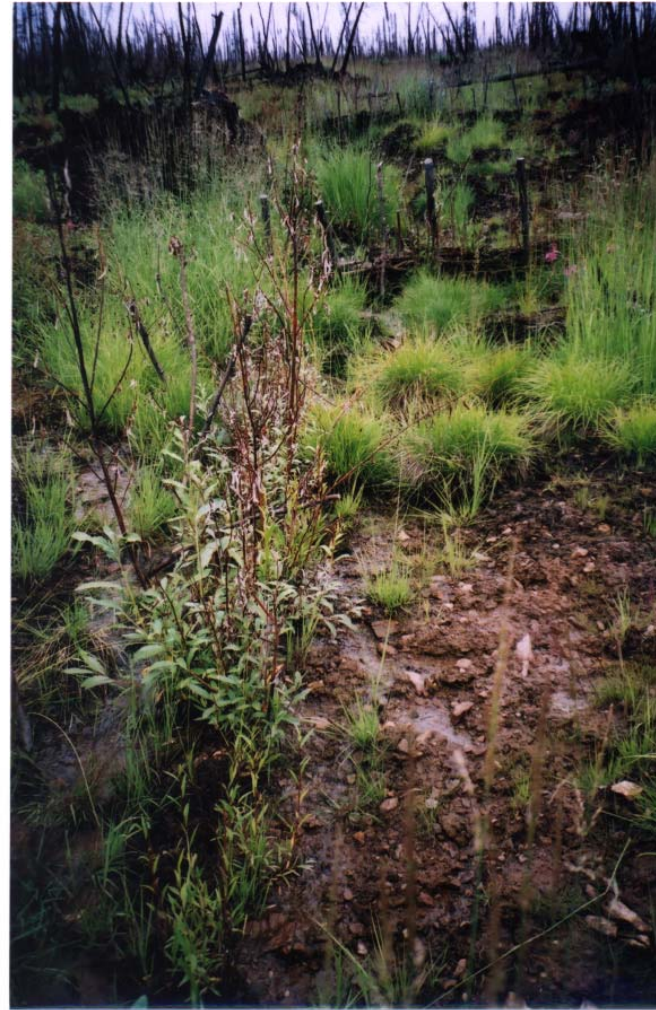
The lower pole drain (between Gully Break # 6 and Gully Break # 7) has been partially burned on top, but the lower cuttings are still sprouting. Water is flowing through and beside the drain.

Lower pole drain – between gully breaks #6 and #7

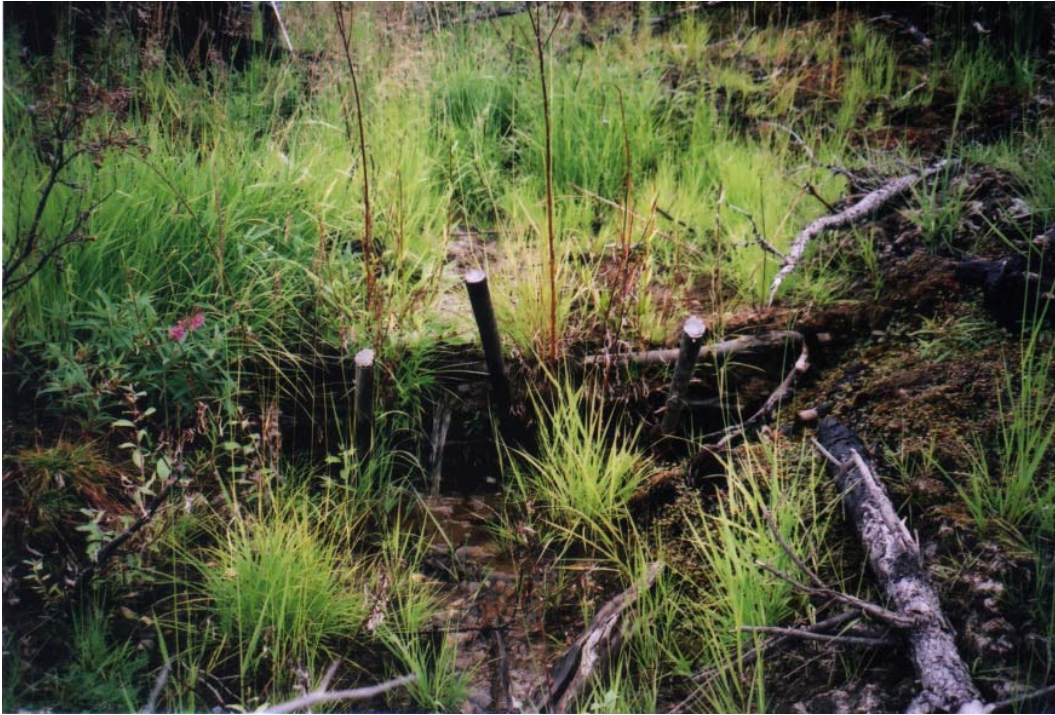
Gully Break #4

Although Gully Break # 4 has been scorched it is trapping sediment and new shoots are sprouting from the lower cuttings. The willow cuttings staked upstream of the break have been scorched, but are producing new shoots at ground level.

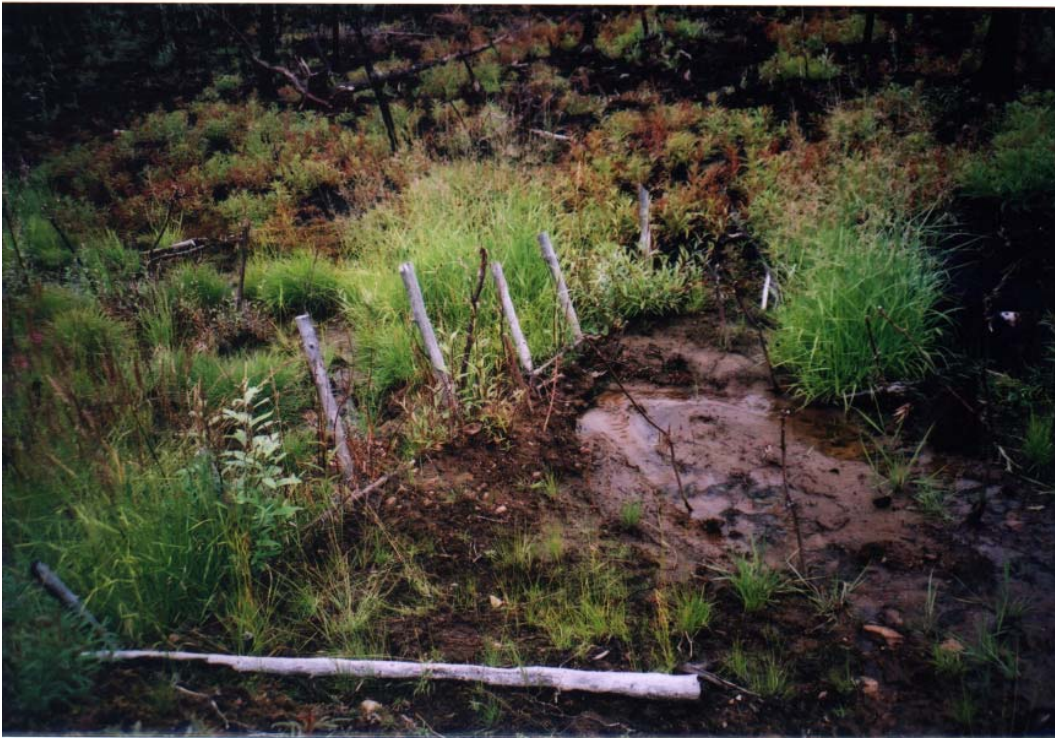
Gully Break #5

Although Gully Break # 5 has been scorched, new shoots are sprouting from the lower cuttings. A major breach in the gully break has occurred at the right bank. The willow cuttings staked upstream of the break have also been scorched, but are producing new shoots at ground level.

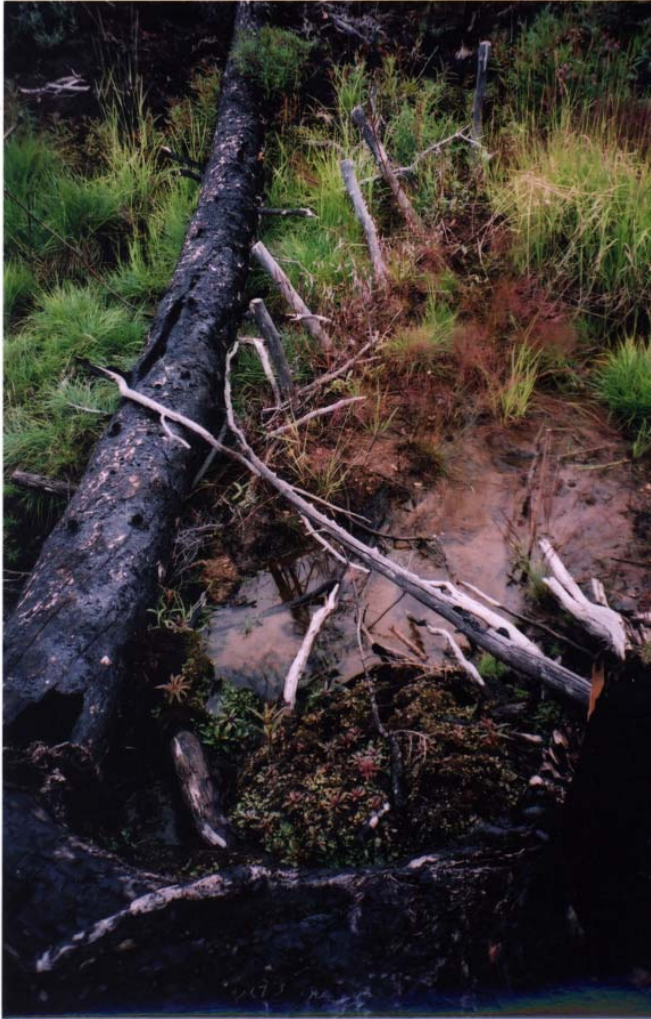
Although Gully Break #9 has been scorched, there is an abundance of new shoots emerging from the lower cuttings. A small breach in the gully break has occurred near the left bank as a result of having been hit by a large falling tree. The willow cuttings staked upstream of the break have also been charred with little sign of new growth.

Gully Break #9 – fallen tree has caused breach

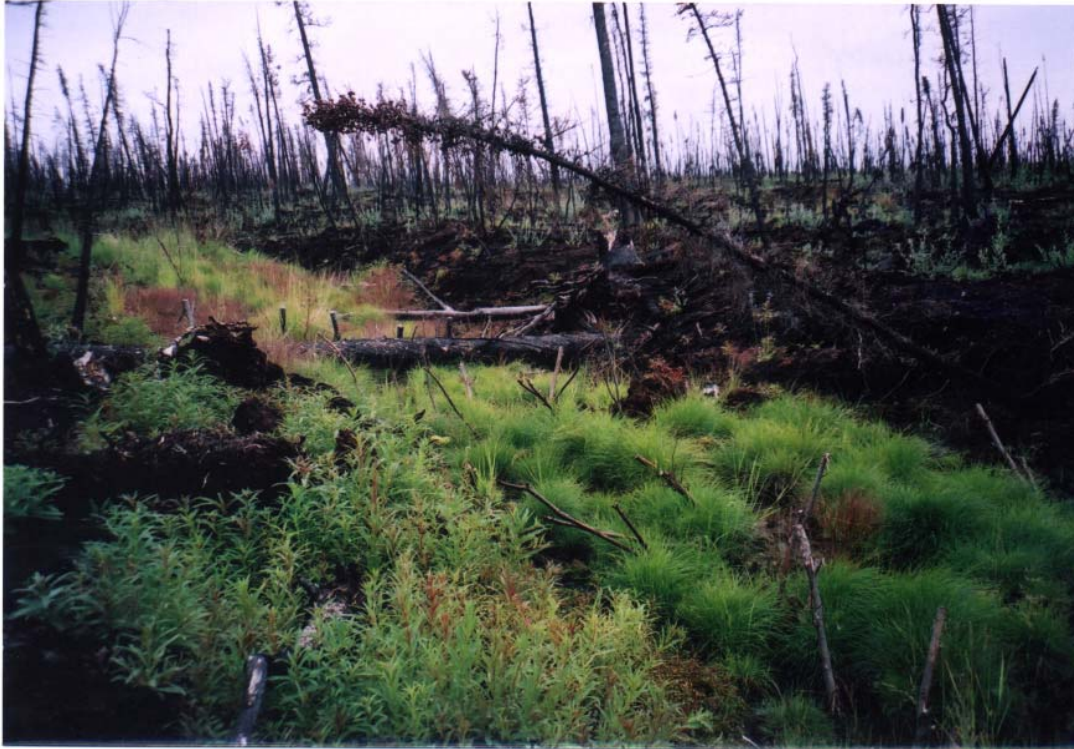
Looking upstream from Gully Break #10

Gully Break # 10 is still trapping sediment although it has been partially scorched. There is new growth along much of the structure. The willow cuttings staked upstream of the break appear to be mostly dead. These cuttings were staked in the fall of 2003 so there was not much time for the establishment of new roots before the fire occurred.

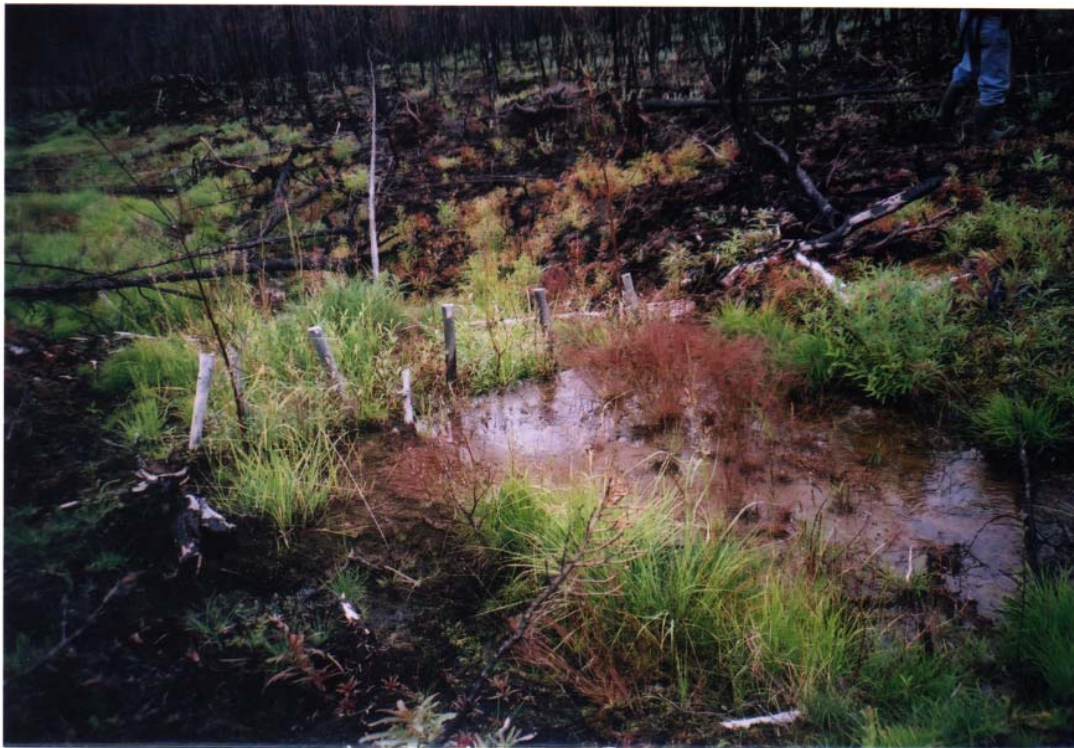
Gully Break #11

The willow cuttings of Gully Break # 11 are mostly still alive. Some of the taller shoots from previous years' growth have been scorched, but there is lots of new growth. The willow cuttings staked upstream of the break have been scorched but there is new growth at ground level.

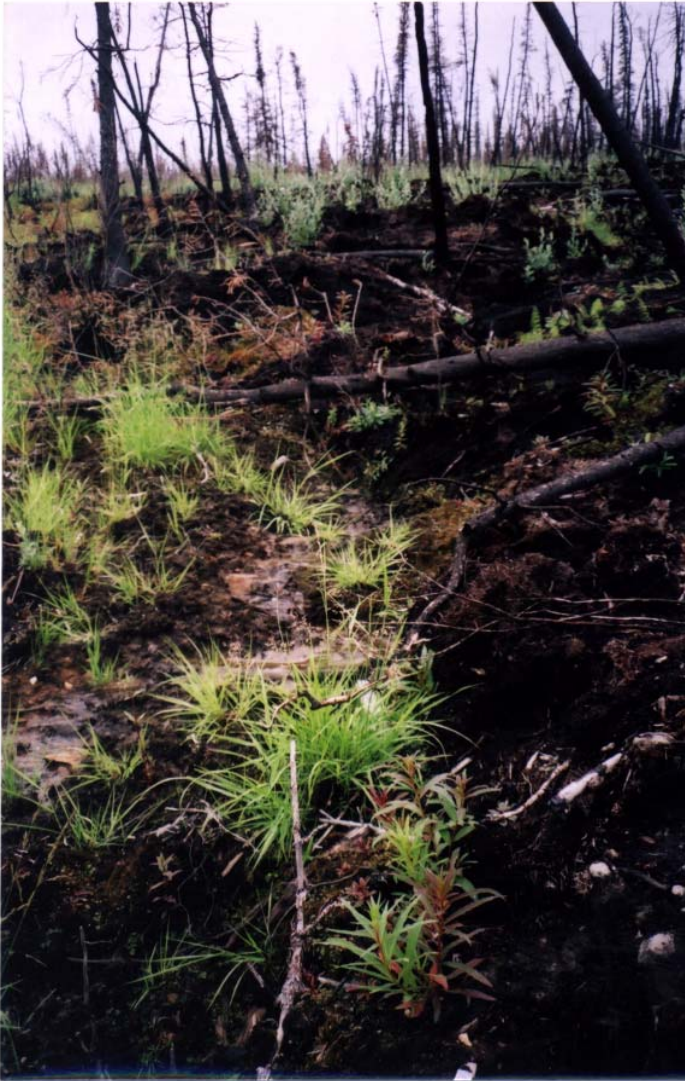
Seepage entering gully by Gully Break #1

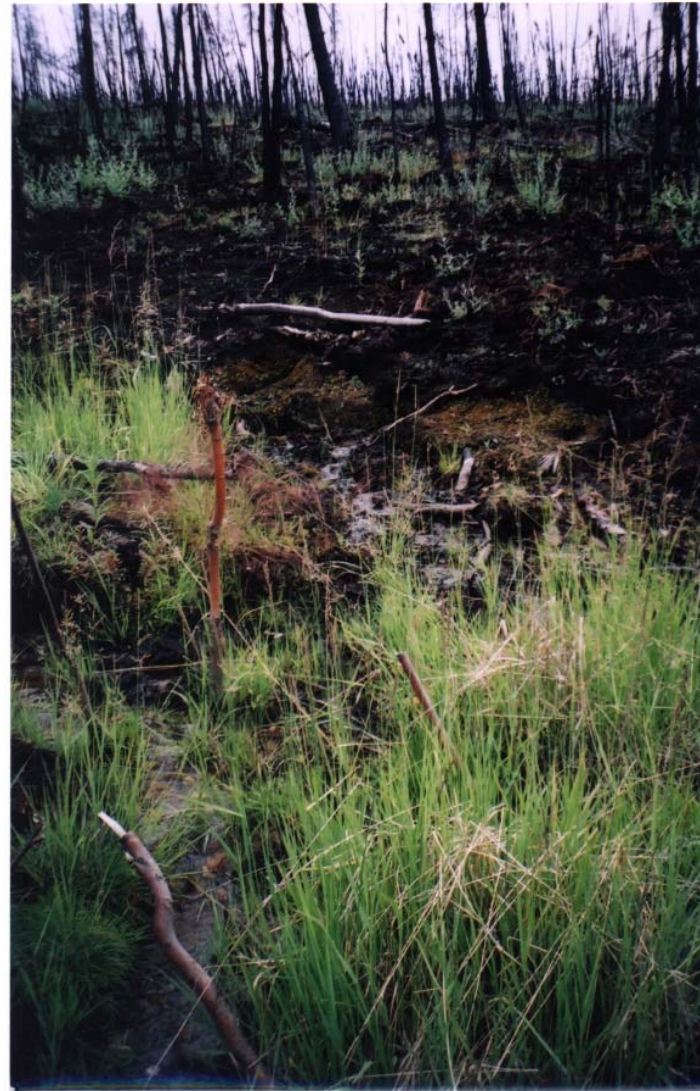
Gully Break # 7 is still trapping sediment although it has been scorched. The taller shoots from previous years' growth have been scorched but new shoots are emerging. The willow cuttings staked upstream of the break have also been charred but are resprouting at ground level. Water is seeping in from the gully sides just upstream from the gully break.

Seepage entering gully by Gully Break #7
